This news bulletin is brought to your desktop by the UK Concrete Repair Association (CRA).

It provides brief and easy-to-digest updates supplied by the CRA and its Members on recent concrete repair developments, new advances and other initiatives occurring in the industry.

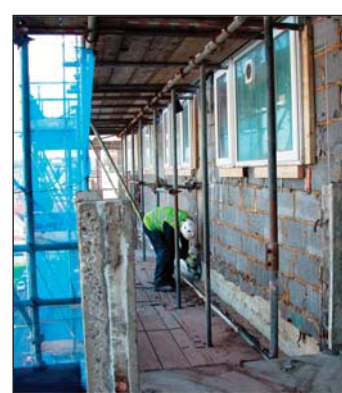
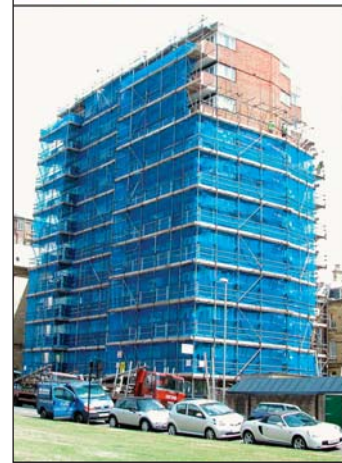
Due to the building's coastal location, however, a number of problems including concrete spalling to the private balconies and ring beams, became evident. Most critically, the ring beams supporting the outer brick skins of the external flank walls were completely delaminated.

Cemplas began by removing all brickwork to the building's outer skin and cutting off (flush) all ring beams. The ring beams were then replaced with steel shelf support anchors that were resin fixed to the remaining face of the concrete and accurately positioned to support the new outer skin of brickwork.

All concrete balconies were shot blasted to remove previous coatings, before a full protective system was applied. Steel reinforcement was treated with additional protective 'cover' before deteriorated concrete was re-instated with high build repair mortar. Finally, an anti-carbonation coating was applied to vertical surfaces and the balcony soffits.

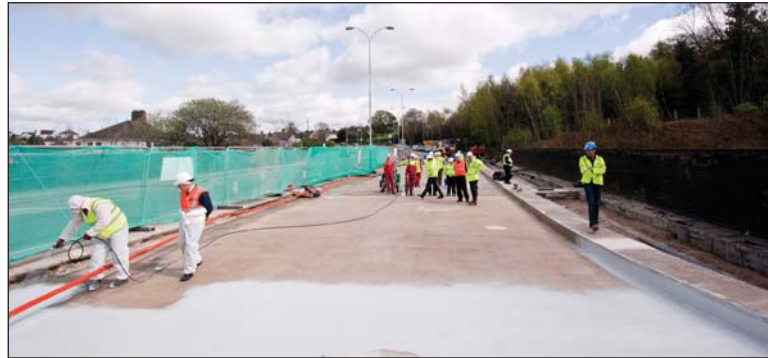
The systems are based on the latest technology, which is essentially a blend of polyurethane (PU) and methyl methacrylate (MMA). They combine the best technical properties that each resin is capable of, whilst at the same time overcoming the limitations that each resin presents when used on its own.

The systems are available for 3 types of exposures. The first between the concrete/steel deck and asphalt overlay or wearing course (BBA & HAPAS Approved System), secondly for completely replacing the asphalt by providing a thick overlay with all the necessary wear, abrasion, waterproofing and slip resistant properties for both vehicular and pedestrian traffic and thirdly, for application on to concrete/steel decks directly under the rail ballast without the need for any protection board.

Unlike conventional MMA Systems, the new technology is unique in that it offers a very high degree of flexibility. Even at temperatures well below freezing they still exhibit exceptional crack bridging characteristics. They are also capable of being installed at temperatures as low as minus 15°C with a 'handover' of as little as 60 minutes after installation.

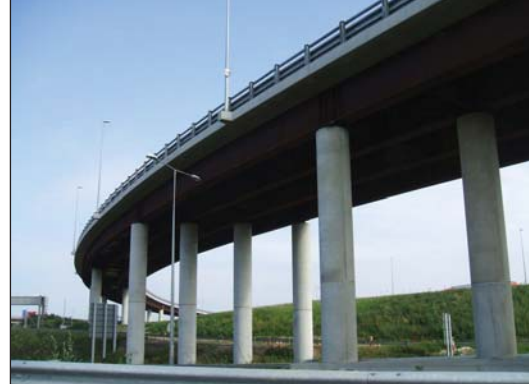
The recent £120m road network improvement scheme around the Dartford Crossing has included a new flyover over the A2 and M25. The sweeping curves of this elevated section are carried on 80 cast concrete columns, each of which carries a bridge bearing supporting the roadway itself and allowing the expansion movement of the roadway structure.

The high level of vibrations generated by the virtually continuous traffic flow at these points of connection demanded the highest quality of fixing and each of the giant 800mm x 800mm bearing pads was grouted to the top of the columns with Five Star\* grout SP, manufactured by CRA member - **Weber**.

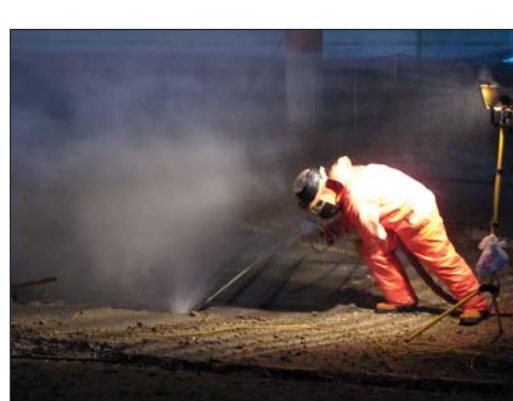
Work to repair a multi-storey car park in Chelmsford, which had been closed for more than six months due to safety concerns, is now nearing completion. High Chelmer Car Park was closed in March after spalling concrete highlighted serious problems with the ageing structure.

Large areas of the concrete decks and ramps, some in excess of 50m<sup>2</sup>, were cut out by hydro-demolition (ultra-high pressure water jets at up to 3000bar) for both speed and reduced vibration. These areas were then reinstated with Sika Armorcrete, a flowable micro-concrete repair mortar. Sacrificial anodes were installed in the repairs to combat the high levels of chloride present in the concrete. Coloured deck coatings and white anti-carbonation coatings to the ceilings and columns will help to stabilise the concrete and brighten up the car park, making it more user friendly.

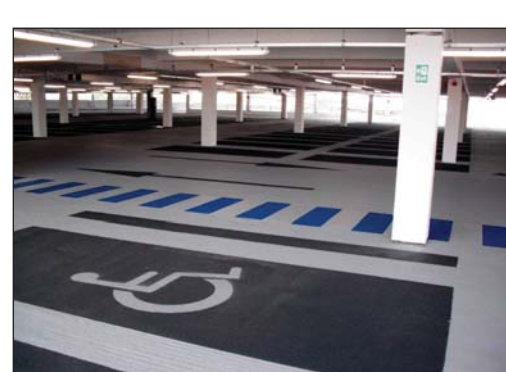
Prior to works commencing, all surfaces were power washed to remove decades of grime. Repairs to the soffits, walls and concrete decks were undertaken using high build mortars and following reinstatement an extensive repainting program was undertaken.

Works included grinding the rough tamped concrete to give an improved finish, before BASF's Protectosil corrosion inhibitor was applied to all concrete decks. The appearance of the running isles were further enhanced by the application of BASF Mastertop 524 to provide a smooth finish. This was followed by the application of BASF Conideck waterproof wearing surfacing throughout all decks. Once concrete repairs were completed, anti carbonation/decorative coatings were applied to provide a bright and airy finish to the structure.
