This news bulletin is brought to your desktop by the UK Concrete Repair Association (CRA).

CRL AWARDED FURTHER PHASE OF PITSEA FLYOVER REFURBISHMENT WORKS

CONCRETE REPAIRS TO VIRGIN ATLANTIC CAR PARK

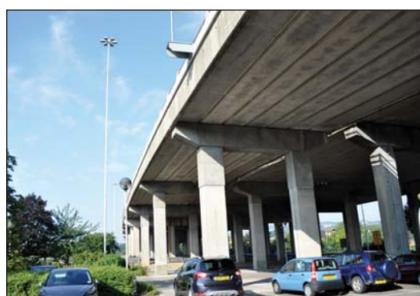
The A13 Pitsea Flyover serves as a major connecting route to the M25 from Southend. It spans a railway line, a local roundabout and a supermarket car park, but has suffered from corrosion problems caused mainly from leaking joints and the 'spreading' of de-icing salts during the winter months.

Various works have been carried out over the years and in November 2009 CRA contractor member, **Concrete Repairs Limited**, was awarded the contract for Phase 5 (by Essex County Council) to carry out major repairs to 15 cross-head beams and to install an impressed current cathodic protection (ICCP) system. The defective areas of concrete were broken out using hydro demolition and were reinstated with sprayed gunite. As with the previous phases of the works, it was decided that the cathodic protection system was to be 'mesh and overlay' consisting of a MMO coated titanium mesh with a sprayed concrete overlay.

To minimise the environmental impact of the works, CRL used noise attenuation boards fixed to the scaffold and the noise levels were regularly monitored. Essex CC was so pleased with the works undertaken, that they awarded CRL Phase 6 of the works (to repair a further 9 piers), which is currently underway.

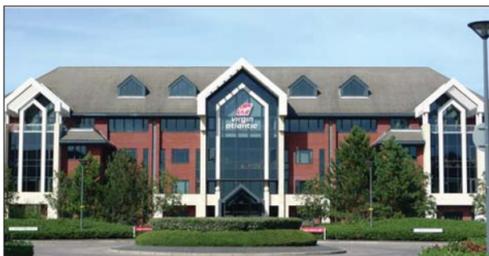
Concrete spalling, spotted on the 2-storey car park at the main Crawley office of Virgin Atlantic Airlines, prompted Virgin Property Portfolio Management to call in CRA contractor member, **Cemplas Waterproofing & Concrete Repairs Ltd.**

Cemplas found that the spalling was widespread across the car park and that the problem, if left untreated, could create a potential health and safety risk to Virgin employees, as well as posing the threat of damage to their vehicles.

Recognising that 'one size fits all' is not the correct approach to providing clients with the best service, Cemplas submitted a detailed survey report, together with a method statement and a lump sum cost to undertake the remedial repairs. As a result, all defective concrete was cut out, prepared and reinstated using Sika Rapid Repair Mortar.

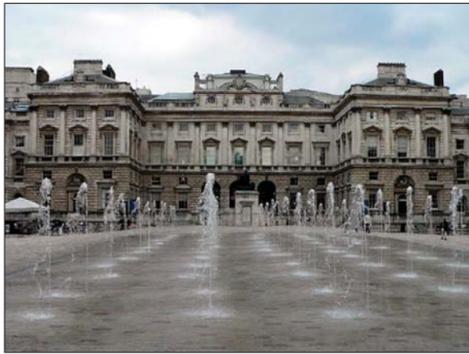
Due to movement, the 800mm thick external masonry walls of Somerset House, London's spectacular neo-classical 18th Century building, have been reinstated with stainless steel helical reinforcing bars by CRA contractor member, **Structural Renovations Ltd.**

In order not to adversely affect the building's external appearance of the building, the bars were resin fixed into drilled holes. In turn, the reinforcing bars were also bedded in slots cut into the perpendicular internal dividing walls, prior to making good and redecoration.

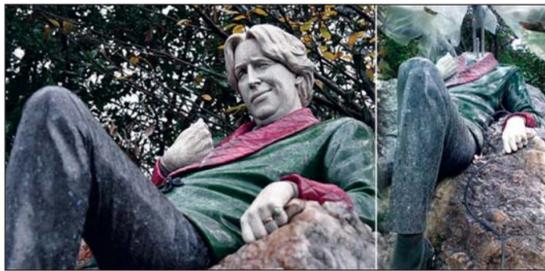
The statue, which was commissioned during the 1990s by the Guinness company and is situated in Merrion Square, across the road from the "Dail" (the Irish Parliament), required the new head after suffering from the rigours of the weather, wear and tear. It had been originally carved from various types of stone including Thulite, Jade and Granite, acquired from countries all over the world.

Parex' distributor had no hesitation in recommending Tecgrip CAS Cartridge and Thixotropic Joint Filler to restore the bond between the statue's body and its missing components after they had begun to crack. The hands were replaced at the same time.

The original sculptor, Danny Osborne, returned to replace the items (originally in porcelain) by new ones replicated in jade, which is a much harder material. These were bonded into place with the same high strength materials used on the original in 1997. The artist confirmed his satisfaction with the Parex products.

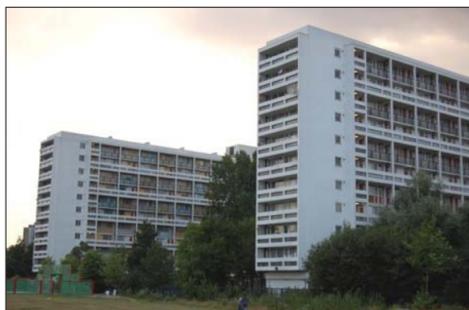
When started, in 1993, the renovation work (which included roofing and window replacement) was the largest concrete repair project in Europe at the time and affected 239 families. As an indication of the size of the project, 20,000m² of vertical surfaces and 10,000m² of soffits have been treated with 14,000 litres of Ronafix, 31,000 litres of Joltec and Zolpacryl.

Following the removal of existing coatings, by low pressure water jetting and grit blasting, Ronabond Fongimousse Plus was applied to kill off mould, fungal growth and algae. The damaged concrete was removed to expose sound concrete and reinforcement steel. Wire brushing was employed to remove rust from exposed steel before it was primed with Ronafix and cement.

Ronafix Mix Design D repair mortar, comprising of cement, sand, Ronafix and water, was applied to reinstate the cut out concrete. Once repairs were complete, a textured slurry coat of Ronafix, cement and sand was applied to the walls and soffits and this was subsequently coated with protective and decorative treatments of Joltec and Zolpacryl.
