M60 Barton High Level Bridge - Refurbishment

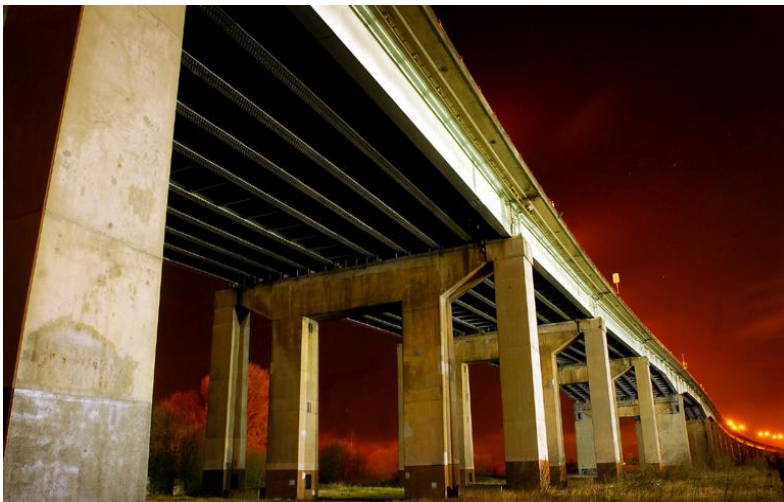
This required careful and detailed methodology to remove the existing joint, fix temporary plates and install new stainless steel cantilever plates bolted to the deck either side of the joint gap to allow eventual installation of a Britflex BEJ/13 expansion joint system.

USL successfully installed 36 Britflex BEJ expansion joints over both carriageways of Barton Bridge, between junctions 10 and 11 on the M60.
